Underwater Acoustic Emission Monitoring – Experimental investigations and acoustic signature recognition of Synthetic Mooring Ropes

Imran Bashir¹, Jodi Walsh^{1,2}, Philipp R Thies¹, Sam D Weller¹, Philippe Blondel², Lars Johanning¹

¹ College of Engineering, Mathematics and Physical Sciences, Renewable Energy Research Group, University of Exeter, Penryn Campus, Treliever Road, Penryn, TR10 9FE, UK

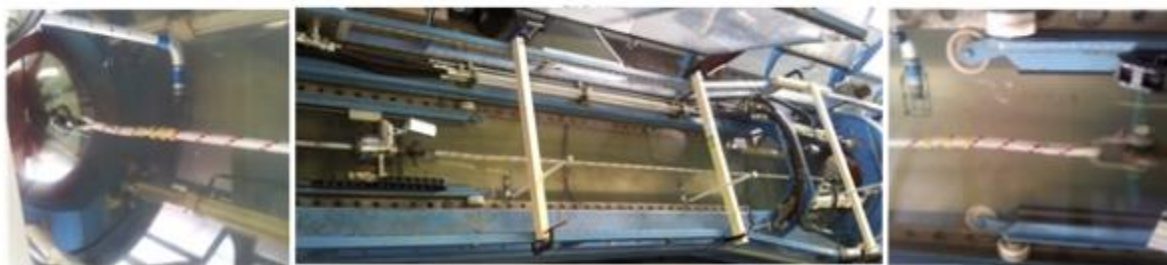
Figure 3: Schematic diagram (top view) and associated photographs showing the experimental set up for underwater acoustic rope testing inside the DMAc test rig.

In order to carry out underwater acoustic testing of polyester ropes, a linear array consisting of three hydrophones was installed inside the DMAc test rig. Two of the sensors were SQ26-08 Cetacean cylindrical shaped directional hydrophones and the third was a ball-shaped JS-B100-C4DS-PA Integrated Acoustic Sensor. Table III summarizes the specifications for both types of hydrophones used. The two cylindrical hydrophones were placed at the two ends of the rope samples close to the splices ('Headstock hydrophone' and 'Z-ram hydrophone') and the third ball hydrophone was placed at the centre of the rope samples ('Centre hydrophone'). The hydrophones were placed at equal distances (i.e. 1.6 m) along the rope in order to cover the entire length of the rope. A schematic of this configuration and photographs of the mounted hydrophones are shown in Figure 3.

The test rig was filled with fresh water and the rope samples were submerged 10 cm deep. The hydrophone array was placed at a distance of 10 cm next to the length of the rope and at the same depth in the water. The hydrophones were enclosed in a wire cage to protect them from damage. Similarly, the cables of the hydrophones were passed through PVC pipes for protection. The pipes were filled with self-expanding foam to avoid them acting as acoustic wave-guides. The hydrophones were fixed to the rig using G-clamps and timber with the use of protective padding to avoid the transmission of any external vibration.
